# Manhole Inspection Summary

Manhole # S05EE2002MH

**Location** Address: **6212 WOODCREST AVE**

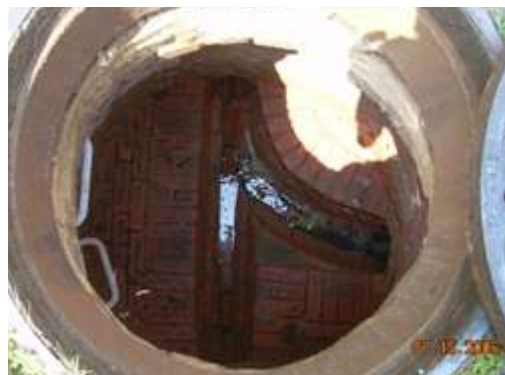
Top View

☒ **Leaks**

Condition: ☐ Sound ☐ Cracked ☐ Root Intrusion ☐ Loose Brick ☒ **Deteriorated**

Infiltration: ☐ None ☒ **Joint** ☐ Cracks ☒ **Mortar** ☐ Roots ☐ Wall

Infiltration: ☐ None ☐ Joint ☐ Cracks ☒ **Mortar** ☐ Roots ☒ **Wall**

Frame leaks. Frame offset. Adjustment deterioration and infiltration. Barrel infiltration. Bench and Channel debris.

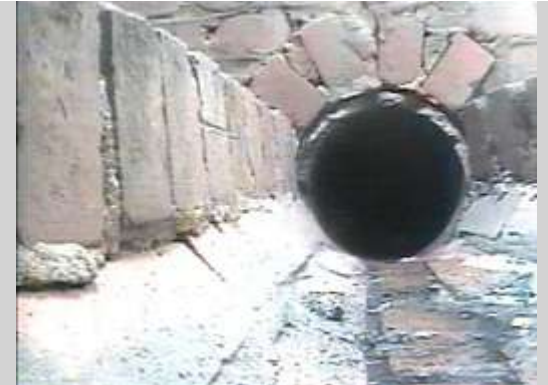
### 8 in. Circular Gravity Sewer Pipe Out @ 12 O'Clock

Comments **The O12 pipe seal is not flush to the pipe. The I3 pipe seal is not flush to the pipe.**

Barrel deterioration and infiltration. Channel deterioration.

Infiltration: **Evidence** Pipe Seal Cond: **Unknown**

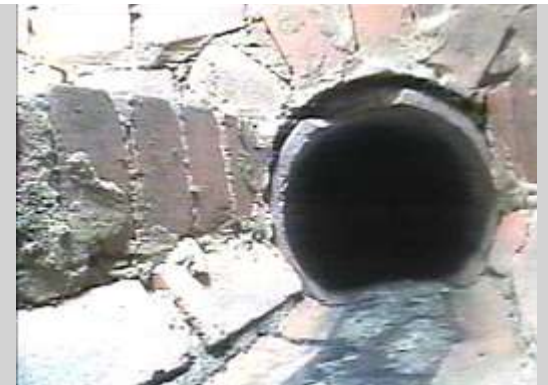
### 8 in. Circular Gravity Sewer Pipe In @ 3 O'Clock

Channel deterioration.

Infiltration: **Evidence** Pipe Seal Cond: **Broken**

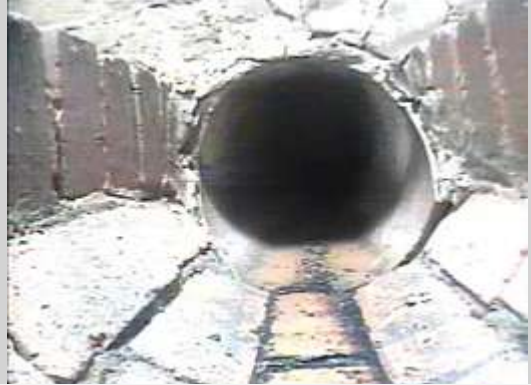
8 in. Circular Gravity Sewer

Infiltration: **Evidence** Pipe Seal Cond: **Cracked**
